Manhole Inspection Summary

Manhole # S07AA2021MH

Location Address: **5927 WESTERN RUN DR**

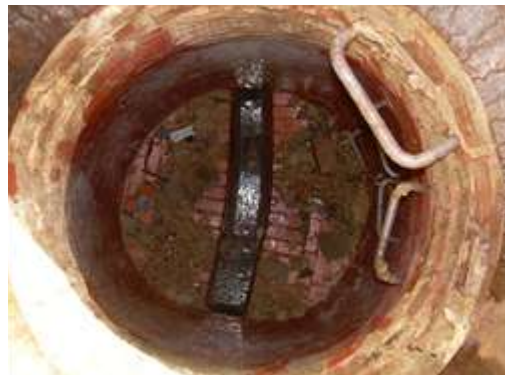
Top View

Evidence of surcharge - Bench debris.
Channel debris.

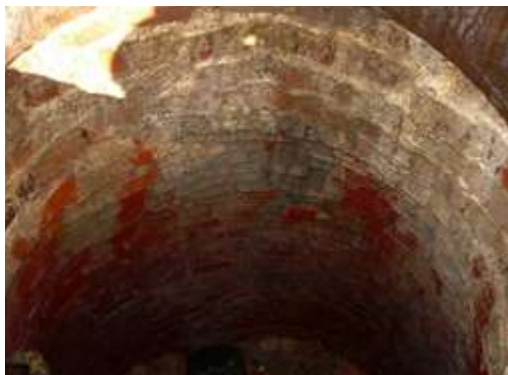
Defect

Adjustment, Corbel, and Barrel infiltration
- other side.

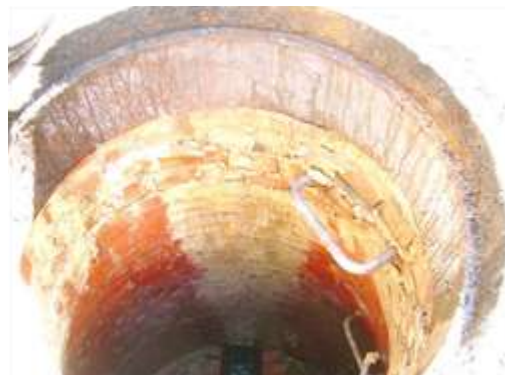
Defect

Adjustment deterioration, loose brick and
infiltration. Corbel and Barrel infiltration.

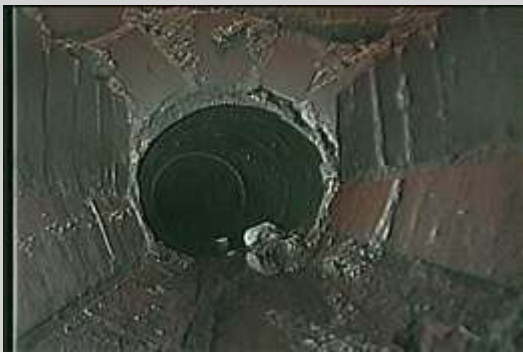
8 in. Circular Gravity Sewer Pipe Out @ 12 O'Clock

Infiltration: **Evidence** Pipe Seal Cond: **Unknown**

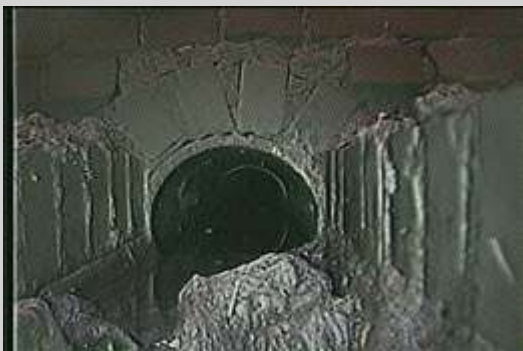
8 in. Circular Gravity Sewer Pipe In @ 6 O'Clock

Barrel deterioration and infiltration. Channel deterioration and debris.

Infiltration: **Evidence** Pipe Seal Cond: **Unknown**
